## Long-term behaviour of bare, bolted busbar joints

with and without the connecting element MC-SEALconTACT

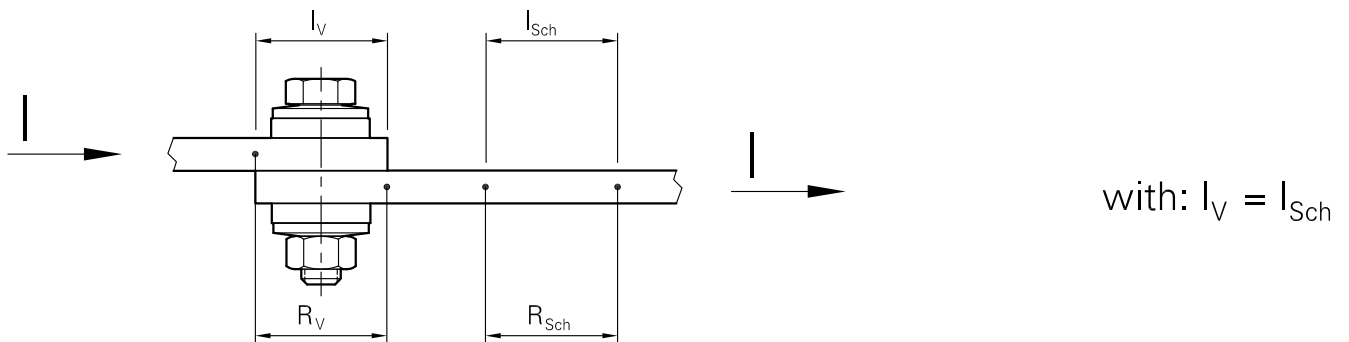
**Figure 1**  
**Joint resistance  $R_v$  and resistance factor  $k_{ij}$  of bolted busbars**  
 $R_v = R_b + R_e + R_f$  (Equation 1)

According to [1], the joint resistance  $R_v$  of a busbar joint, Figure 1, is the sum of several resistances as indicated by Equation 1.

$R_b$  is the internal resistance of both busbars over the overlap length  $l_v$ , on the assumption that the busbars are joined metallicity homogeneously. In other words, where the contact resistance  $R_{ij}$  according to Equation 2 equals zero.

$R_{sch}$  is the resistance of a busbar section  $l_{sch}$  long, which is equal to the overlap length  $l_v$ .

As indicated by Equation 3, the resistance factor  $k_u$  is the ratio of the joint resistance  $R_v$  over the overlap length  $l_v$  to the busbar resistance  $R_{sch}$  of a busbar of equal length  $l_{sch}$ .

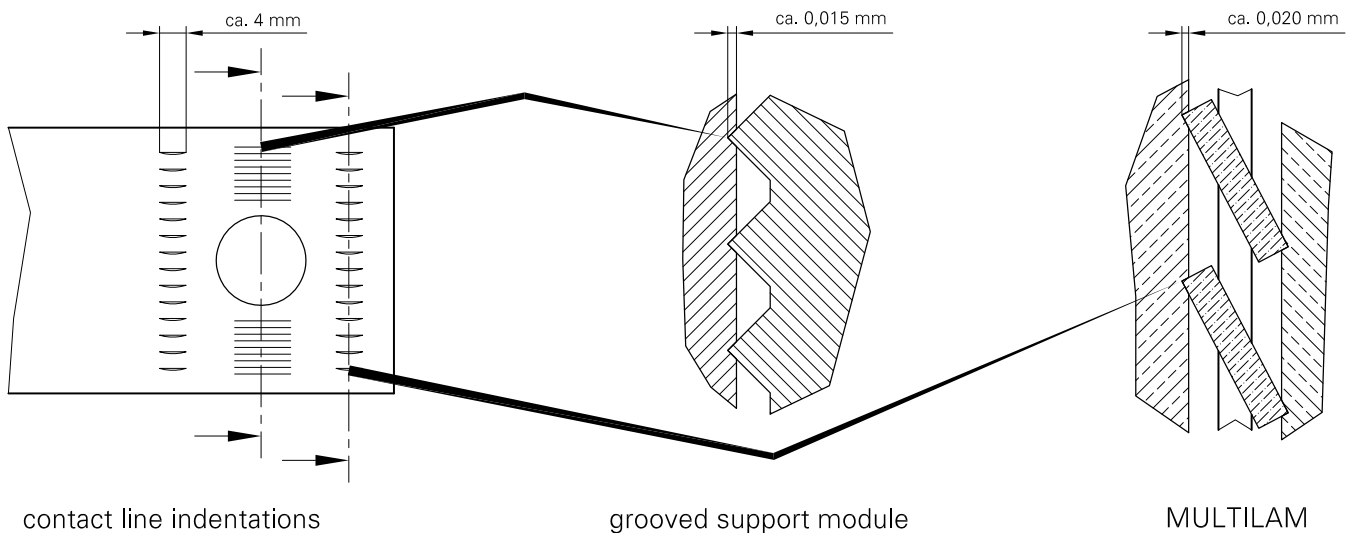
e.g. Oxide film of Al-busbars  
2 nm (Mean value) = 0,000002 mm

**Figure 2**  
**Penetration of the impurity film by the grooved support module and the MULTILAM**

The support module's main function is to limit the compression of the torsion-spring louvers to ensure optimal contact. Providing the module with grooves adds an effect similar to that of the louvers

themselves, namely that the peaks between the grooves break through the impurity films and bite into the busbars to ensure even contact between the two surfaces.

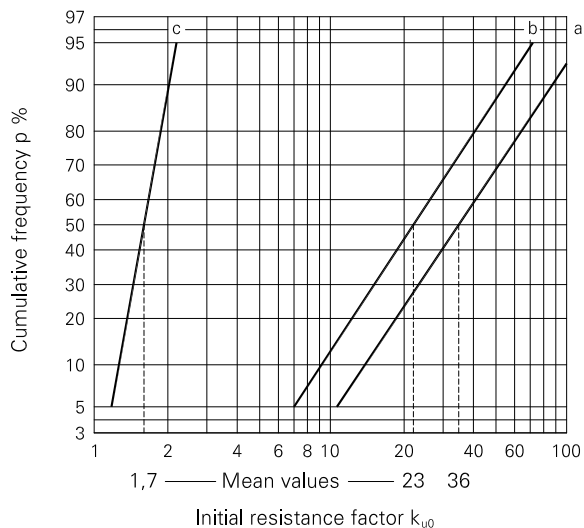
**Figure 3**  
Empirically determined initial resistance factors  $k_{u0}$  of joints without MC SEALconTACT.

- Curve a: uncleaned
- Curve b: cleaned optimally and then touched by a dirty hand
- Curve c: cleaned optimally

Figure 3 presents figures for various surface pretreatment practices used to make up busbars joints without MC-SEALCONTACT. Figure 4 shows a virtually identical initial resistance factor of  $k_{u0} = 1,5$  of busbars with MC-SEALCONTACT for the material pairs Cu-Cu, Al-Al and Cu-Al, cleaned and uncleaned, indoor duty, outdoor duty, and exposure to rainwater.

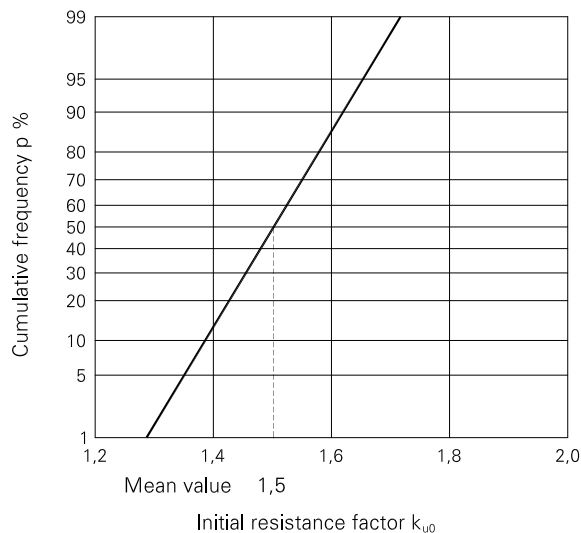
**Figure 4**  
Empirically determined initial resistance factors  $k_{u0}$  of joints with MC SEALconTACT.

- of cleaned and uncleaned busbars
- Cu-Cu, Al-Al, Cu-Al
- indoor duty, outdoor duty, exposure to rainwater

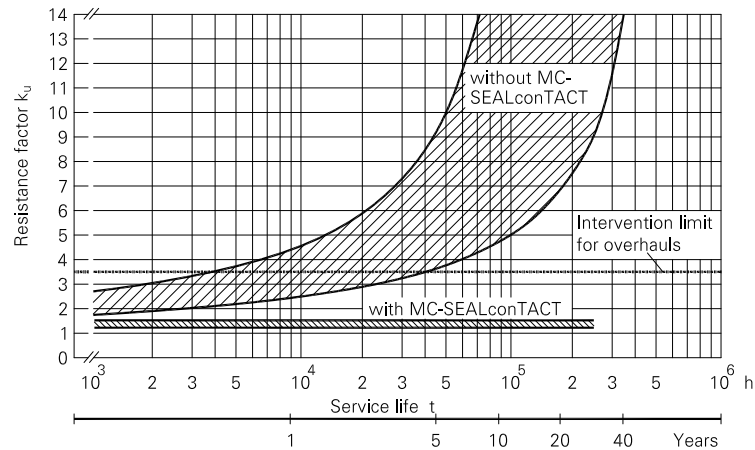
**Figure 5**  
Long-term resistance factor  $k_u(t)$

Investigations described in [2] demonstrate that the long-term resistance factor  $k_u(t)$ , as shown in Figure 5, depends largely on the initial resistance factor  $k_{u0}$ . Joints with high original resistance

Shown in Figure 5

The curves were determined experimentally [2] for indoor applications. The bandwidth between the two curves was determined by two different variables:

- different initial resistance factors,  $k_{u0}$
- different temperature combinations

If the electrical loss costs are to be minimized or kept at an economically justifiable level, the joint should be overhauled as soon as its resistance factor  $k_u$  reaches 3,5.

These curves apply to both indoor and outdoor applications. The forecast long-term behaviour is based on extensive environmental simulations employing accelerated aging (Appendix) and on the functional properties of torsion-spring louvers as determined by many years of actual service. In outdoor applications, the sealing frame of the contact and support modules is doubly important.

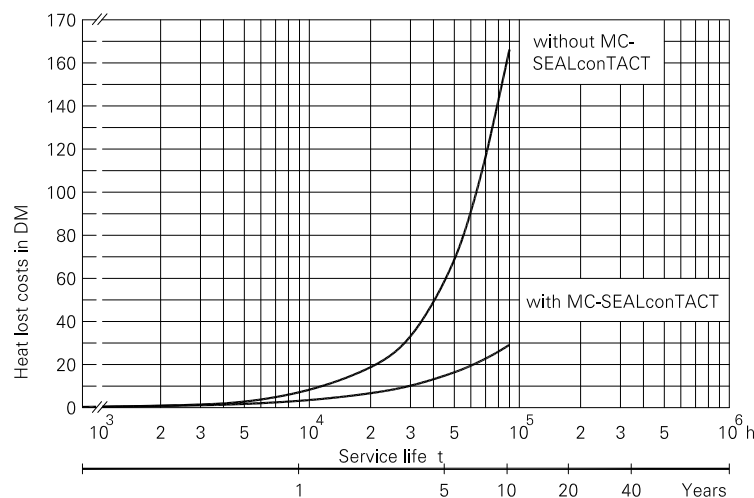
**Figure 6**  
Prospective energy cost savings achievable with the connecting element MC-SEALconTACT

Figure 6 shows the comparative costs of the heat losses caused by the contact resistance  $R_{\bar{u}}$ . The curves do not include the heat losses in the busbars caused by the internal resistance  $R_b$ .

The calculations are based on a busbar joint that occurs very frequently in power distribution systems.

Busbar material:	aluminium, bare
Dimensions:	40 mm x 10 mm
Current:	600 A, constant
Initial resistance factor, $k_{u0}$ :	1,5
Long-term resistance factor, $k_u(t)$ :	averages from Figure 3
Service period:	up to 10 years
Energy price:	€ 0.08/kWh
